OSWALD DAM

ATCHISON COUNTY, MISSOURI

MO. 11031

**PHASE 1 INSPECTION REPORT
NATIONAL DAM SAFETY PROGRAM**

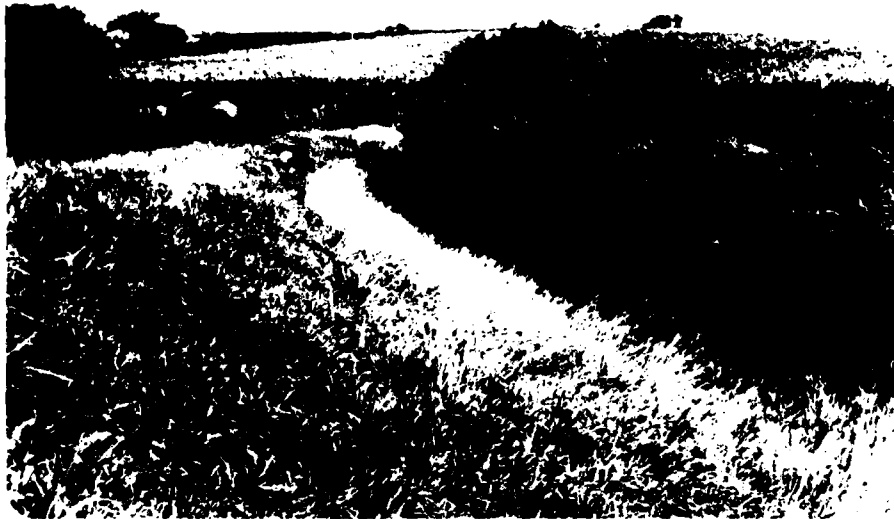
PHOTO NO. 6 - DOWNSTREAM SLOPE FROM RIGHT ABUTMENT.
